Water-Data Report 2008

**0208700550 LITTLE LICK CREEK AT NORTH CAROLINA HIGHWAY 98 AT OAK GROVE, NC**

Neuse Basin  
Upper Neuse Subbasin

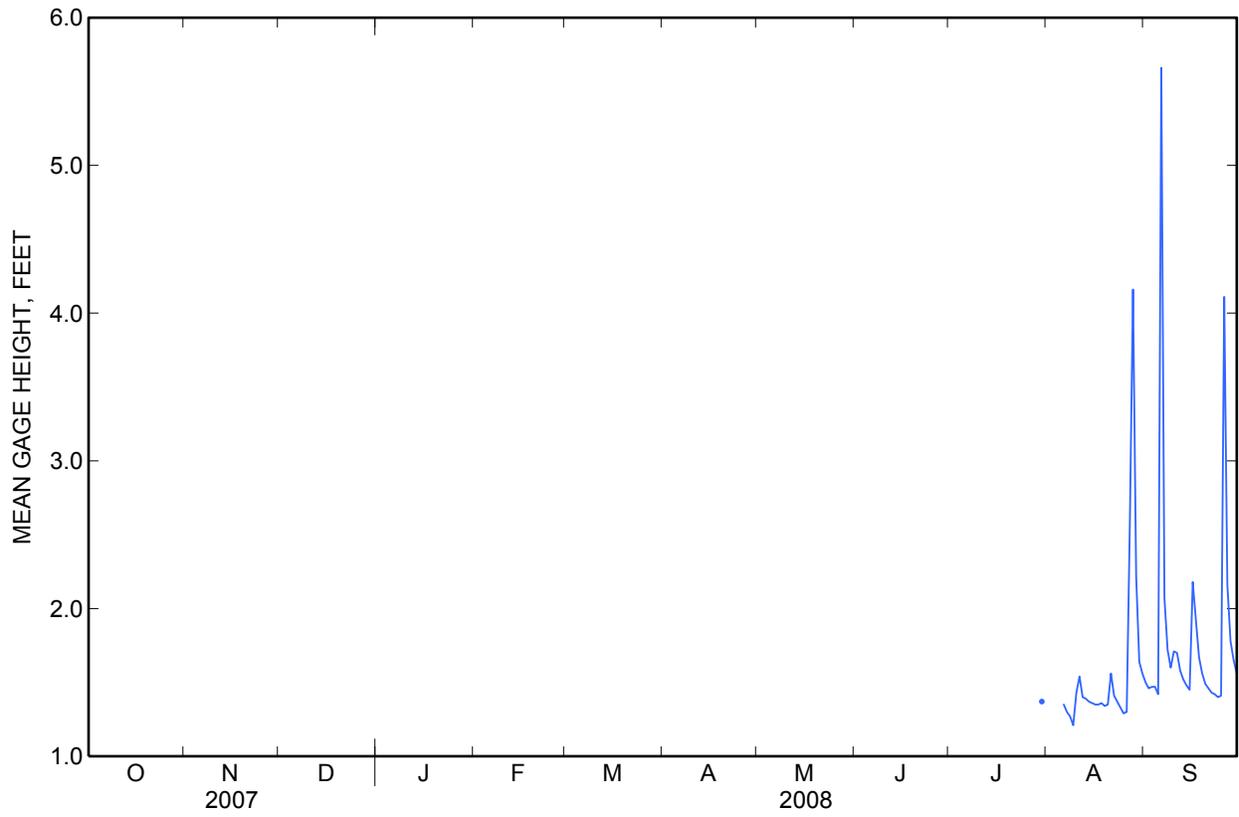
0208700550 LITTLE LICK CREEK AT NORTH CAROLINA HIGHWAY 98 AT OAK GROVE, NC—Continued

GAGE HEIGHT, FEET  
 WATER YEAR OCTOBER 2007 TO SEPTEMBER 2008  
 DAILY MEAN VALUES
